REPORT NUMBER: FHWA-AZ--8601 1992

HILFIKER REINFORCED SOIL EMBANKMENT WITH FULL- HEIGHT, CAST-IN-PLACE CONCRETE PANELS

Final Report

May 1992

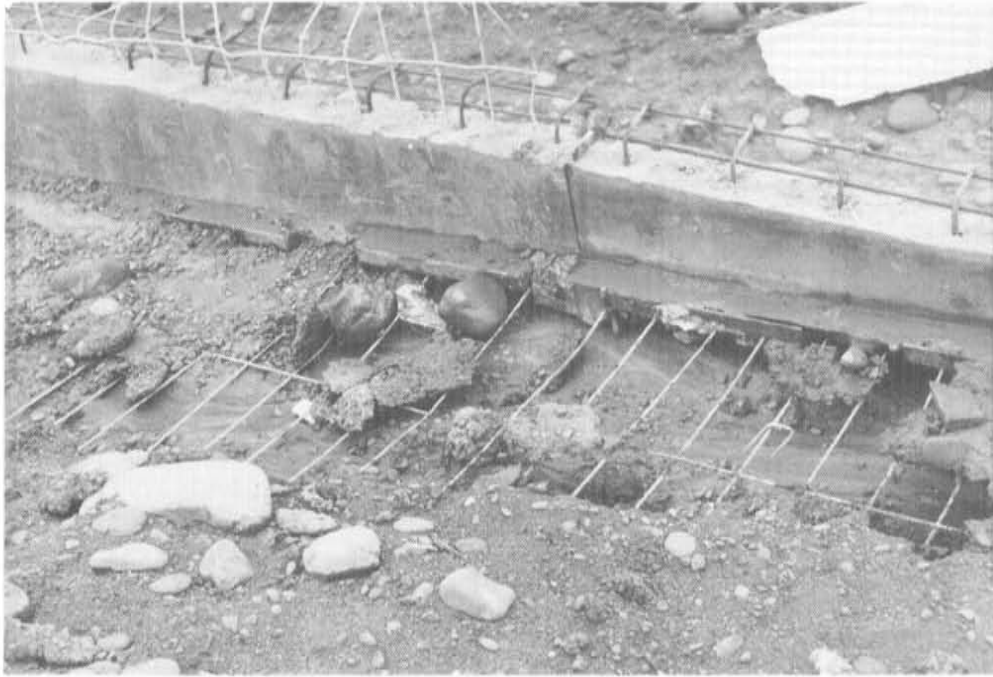
Attempts were made by the contractor to use only backfill material passing a 4" sieve in the 2' nearest the backing mats for the northeast and southwest walls. This was not required in the specifications, and quite often did not take place, as illustrated in Figure 12.

Figure 12 Backfill Material Larger Than a 4 " Sieve Placed Near the Backing Mats.

1. Backfill material used for similar projects should pass a 3" sieve. This recommendation is based on the experiences of this project. The finer material facilitated construction and was more readily compacted.
2. Compaction requirements for the backfill material should be increased from 90%, as specified for this project, to 95% of the maximum dry density. This may alleviate differential settlement between the area beneath the Hilfiker mats (90% compaction) and the rest of the embankment (95% compaction). This recommendation is consistent with ADOT Specification 205-3.04.
3. Better finish of the concrete panels may be achieved with a thicker wall. Construction of the forms for a thicker wall would allow more room for the use of vibrators. Also, forms constructed of steel, or a similarly rigid material would allow for better results of exterior vibrators.

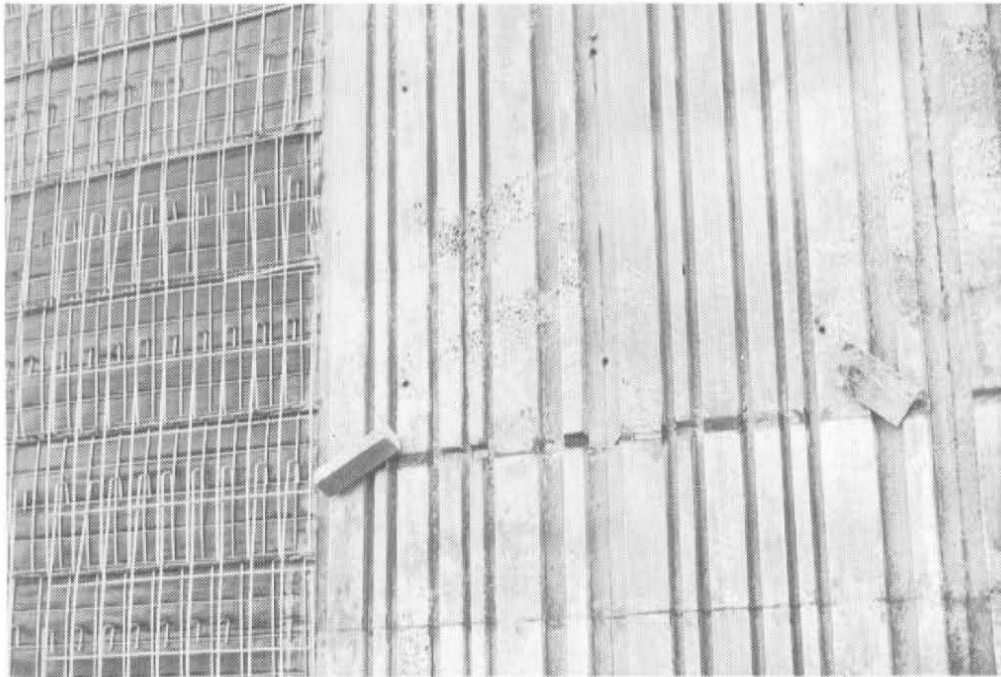
The concrete was mixed at a batch plant and delivered to the site in transit mixers. The concrete was poured down the full face of the embankment, at times over 20'. Upon pouring, the concrete was vibrated with long internal vibrators as shown in Figure 16. After removing the forms, the concrete showed extensive honeycombing and air voids. Therefore, external vibrators were used in addition to the long internal vibrators. However, because the vibrations of the external vibrators did not transfer well through the rubber and wood forms, honeycombing and air voids were still visible. Use of external vibrators is shown in Figure 17. Figure 18 shows an example of the honeycombing and air pockets in the concrete panels.

Figure 18 Honeycombing and Air Pockets Visible in the Full-Height Panels.

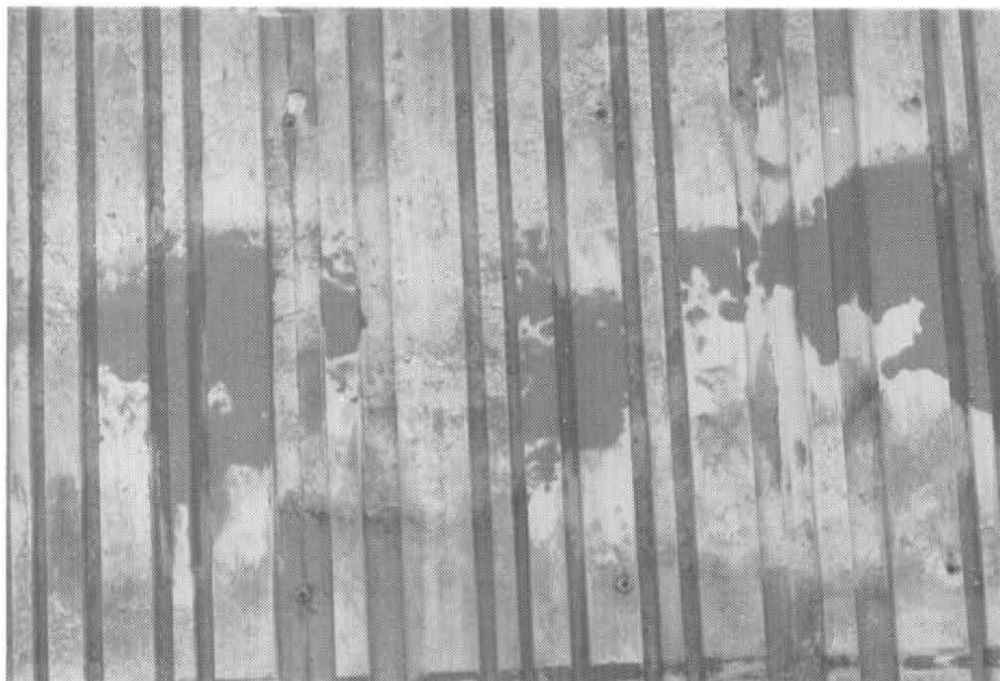
The wall was patched and painted; however, honeycombing and air pockets remained evident as shown in Figure 19.

Figure 19 Honeycombing Was Still Visible After Patching Attempts.

The contractor could not use tremie concrete nor larger diameter internal vibrators because of the limited clearance of the forms. The concrete panels were only 6" wide and had a maximum of 1.5" clearance for the internal vibrators. In an attempt to attain a higher quality finish, three different mix designs were tried by the contractor. APPENDIX H includes the different mix designs, and corresponding typical compression test results.

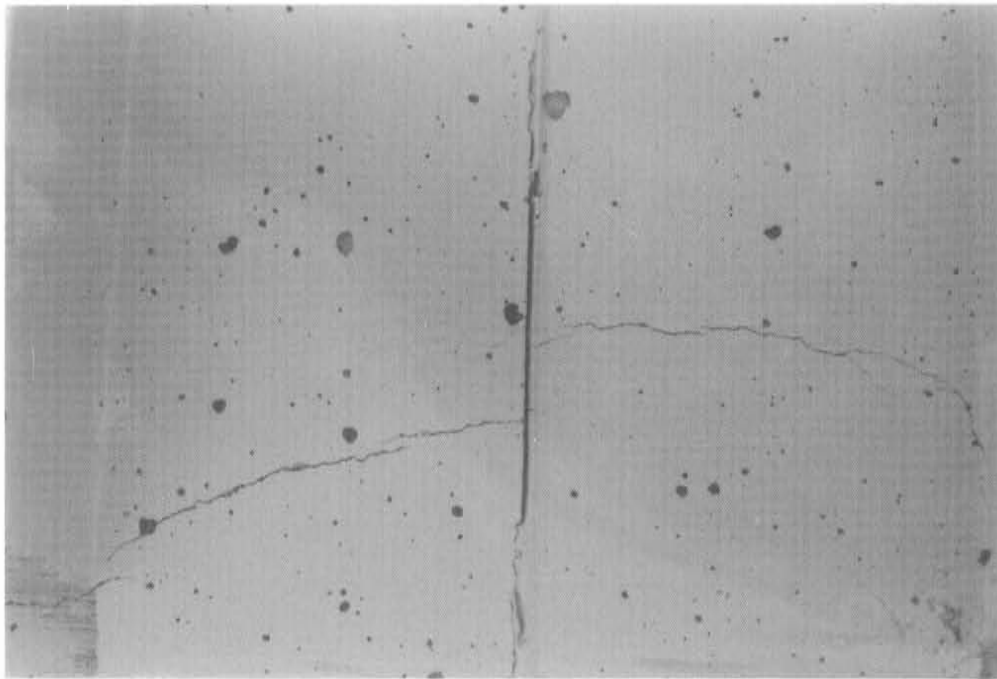
The plans did not provide for drainage outlets in the concrete panels. The panels immediately began to display honeycombing, air voids, and shrinkage and settlement cracks. The cracks were discontinuous and located primarily, but not limited to, the horizontal rustication of the wall. Figures 20 and 21 illustrate the horizontal cracks and air voids.

Figure 20 Hairline Shrinkage or Settlement Cracks and Air Voids.

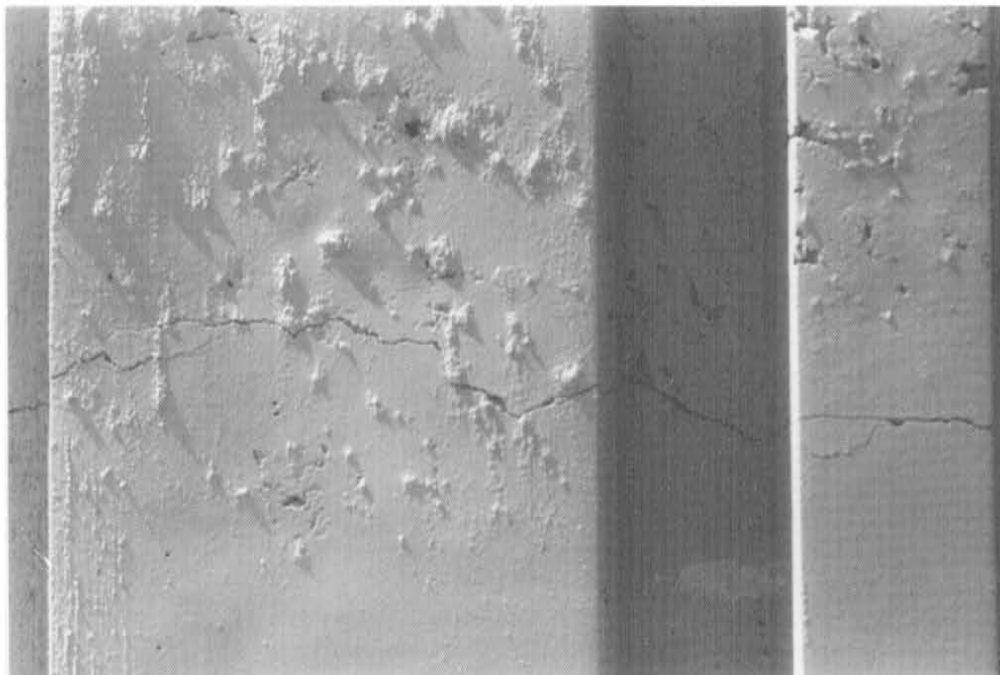
Figure 21 Air Voids and Horizontal Cracks in the Concrete Panels.

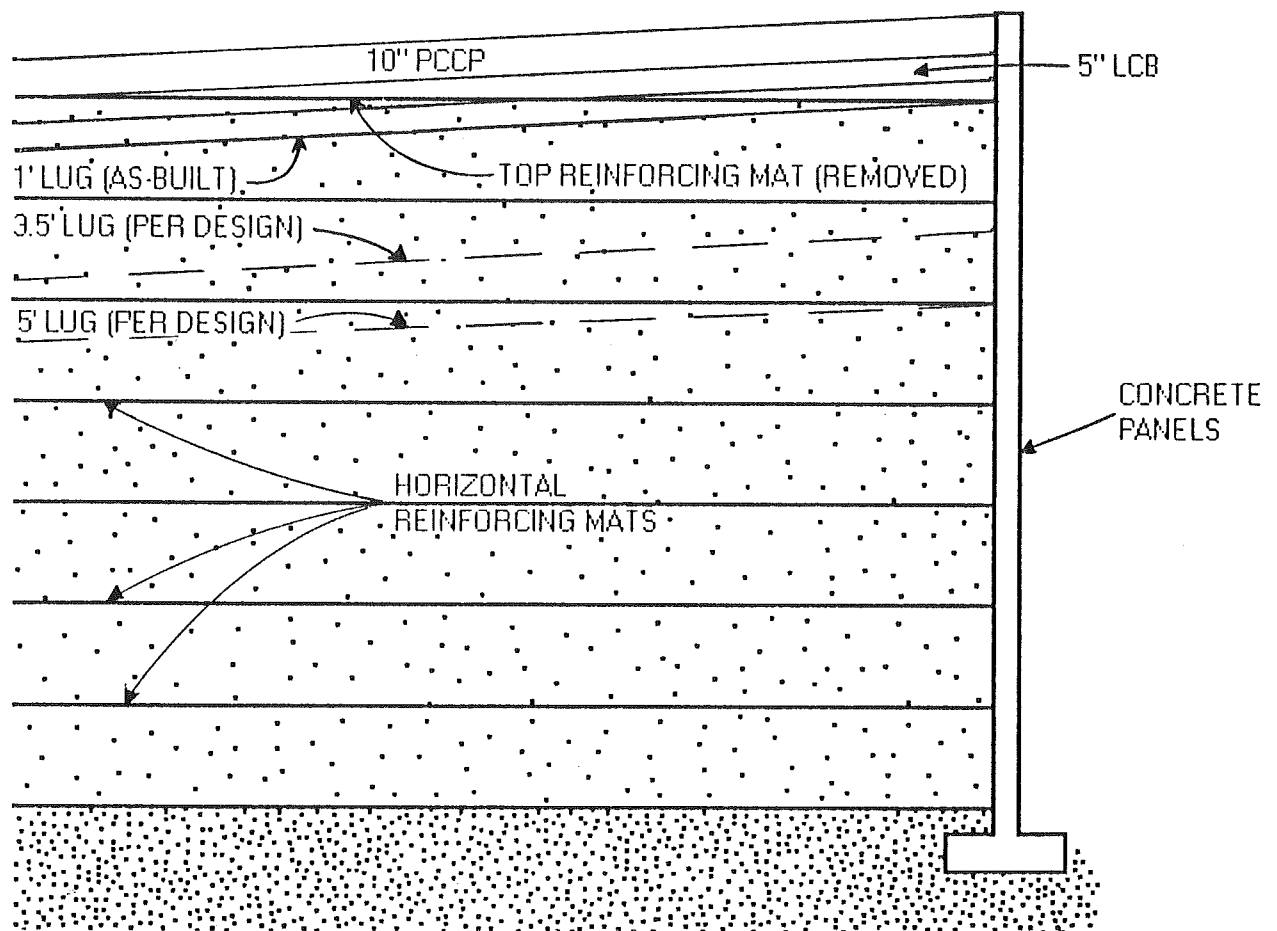
Additional work included removing the top reinforcing mat and backfill to accommodate the 15" needed for the concrete pavement (10" Portland Cement Concrete Pavement and 5" Lean Concrete Base). A design error provided only 6" clearance for the pavement. The work was performed under a \$5000 force account. This force account also provided for the shortening of the lugs of the anchor slab to preclude them from interfering with the reinforcing mats. This is illustrated in a schematic included as Figure 22. The lugs were shortened from the standard 5' and 3.5', to 1'. Another force account required the contractor to seal the construction joint between the Hilfiker wall and the new PCCP. The contractor was provided \$5000 to remove the existing filler and apply a bituminous joint sealant.

Figure 22 Schematic Diagram Illustrating the Conflict Between the top Reinforcing Mat and the Concrete Pavement (View is a Lengthwise Cross-Section).

4. In the design of a particular reinforced soil system, the features of the roadway should be considered. There should be no conflict between the soil reinforcement and the road features such as catch basins, anchor lugs, light pole foundations, etc.

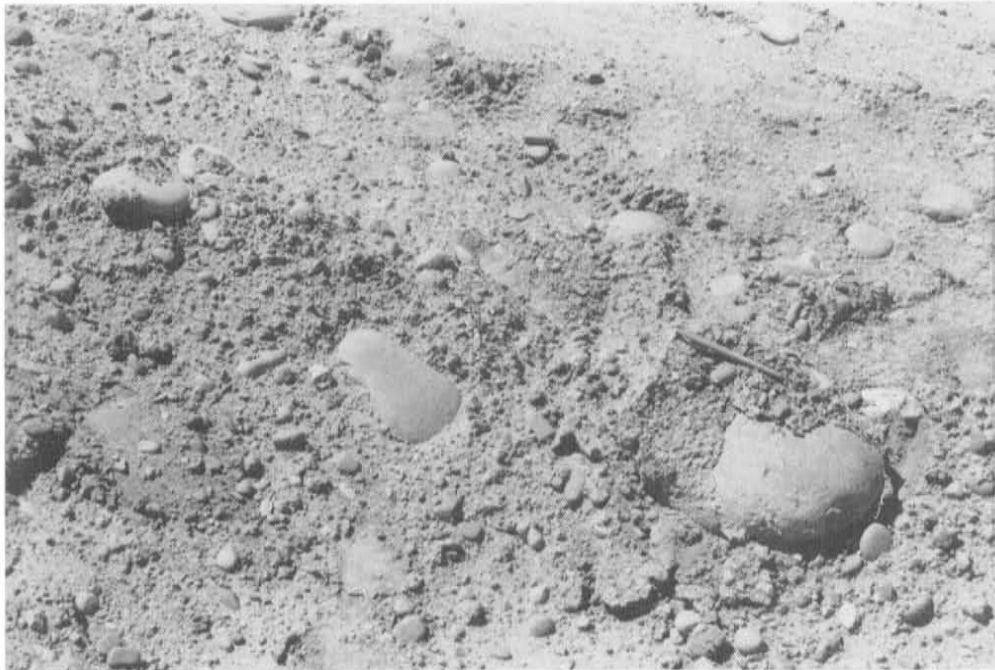
The subgrade for the southwest wall needed to be over-excavated 8.5' to remove existing concrete rubble. A total of 22 field density tests were performed by ADOT during construction of the southwest wall (APPENDIX G). The backfill met density specifications. However, this backfill material did not meet gradation requirements. Project specifications called for all material to pass the 6" sieve. This was clearly not the case as a significant portion of the backfill was greater than 6". Figure 23 shows the varying size of aggregate.

Figure 23 Backfill Material With Rocks Larger Than the 6" Sieve.

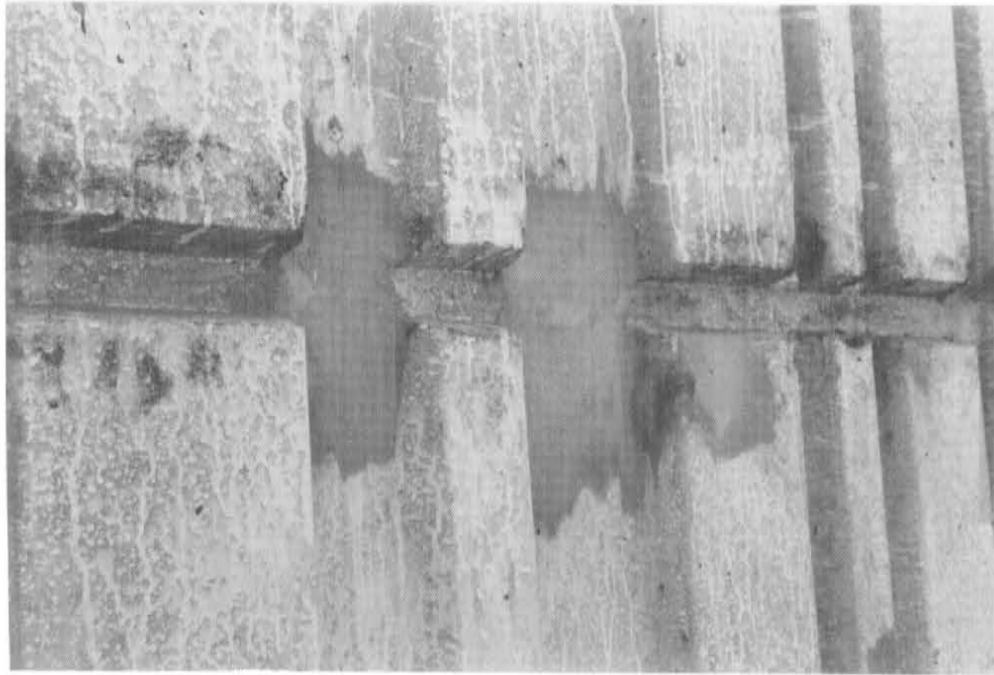
The concrete panels of the face of the wall were poured similarly to the procedure followed for the northeast wall. Consistent with the other walls, there were no drainage outlets provided in the plans. Once again, cracks, honeycombing, and air voids were prevalent along the panels. Figure 24 shows patched honeycombed areas, and Figure 25 shows typical cracks ranging from 0.007" to 0.03" along the horizontal rustication of the concrete wall.

Figure 24 Patched Honeycombed Areas of the Southwest Wall.

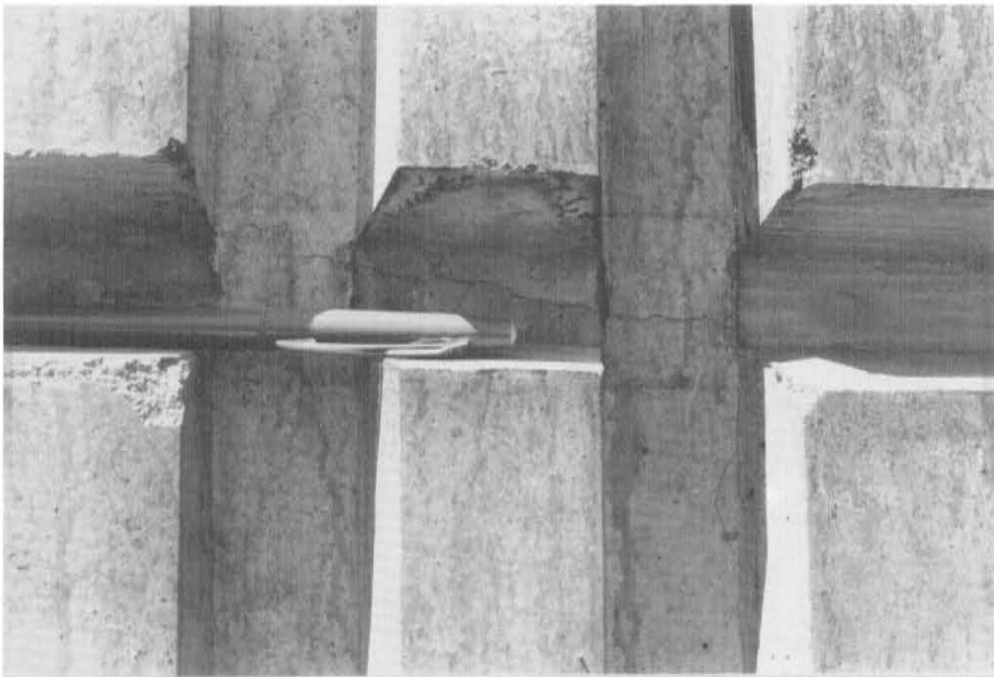
Figure 25 Typical Cracks Along the Horizontal Rustication of the Concrete Panels.

It is believed that these horizontal cracks exist in all of the horizontal rustication of the concrete walls. However, this was not verified at upper portions of the wall due to an inability to access these heights.

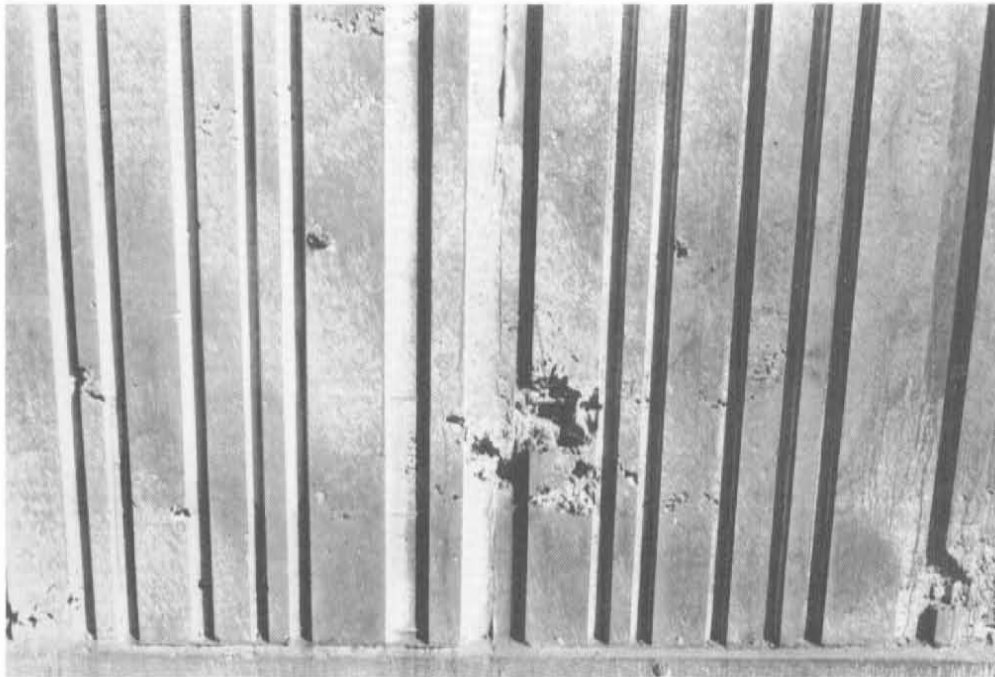
More severe voids and honeycombing, late in the construction of the southwest wall, resulted in the exposure of the embankment reinforcing steel as shown in Figures 26 and 27. In these instances, the contractor broke the face of the panels and replaced them with a higher quality concrete finish. Another remedy was extensive patching, shown in Figure 28.

Figure 26 Exposed Reinforcing Steel Due to Severe Honeycombing.

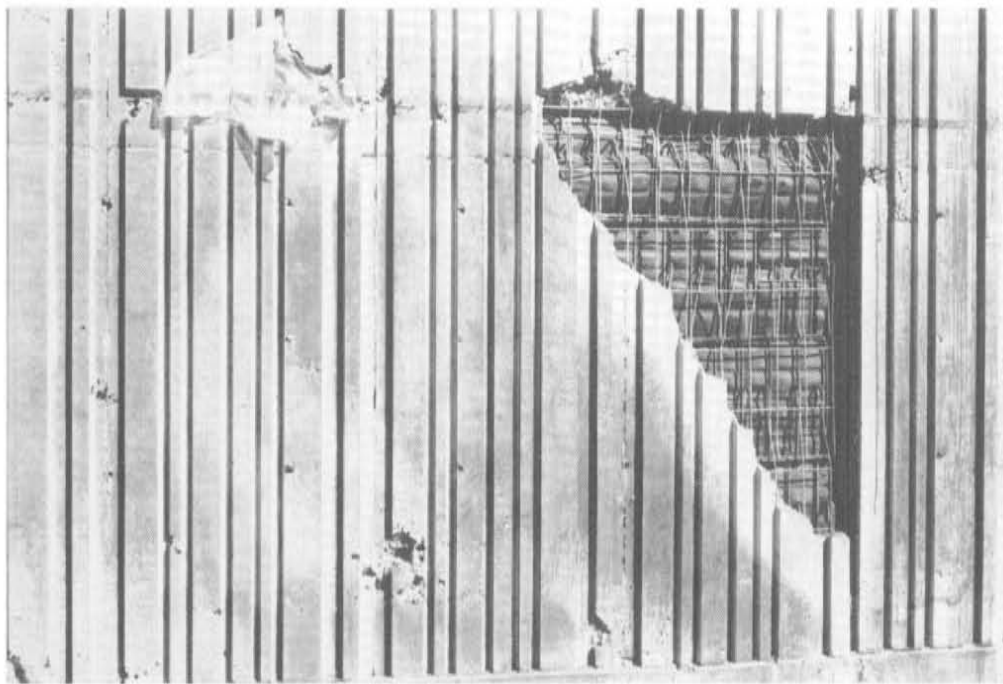
Figure 27 Two Panels That Needed to be Broken Out and Replaced.

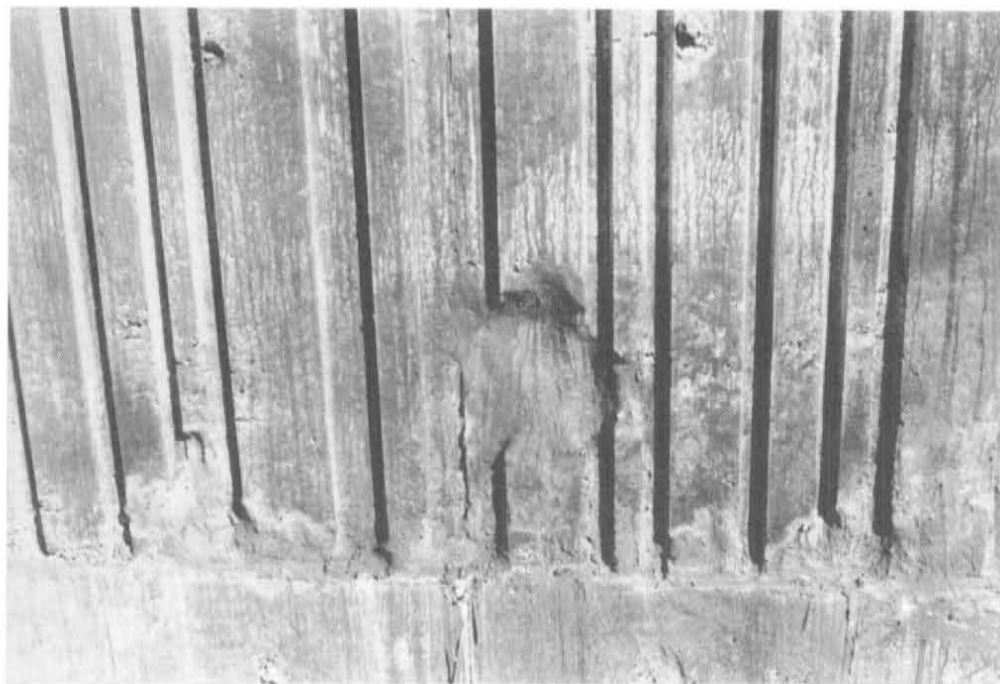
Figure 28 Severe Honeycombing Treated by Patching.

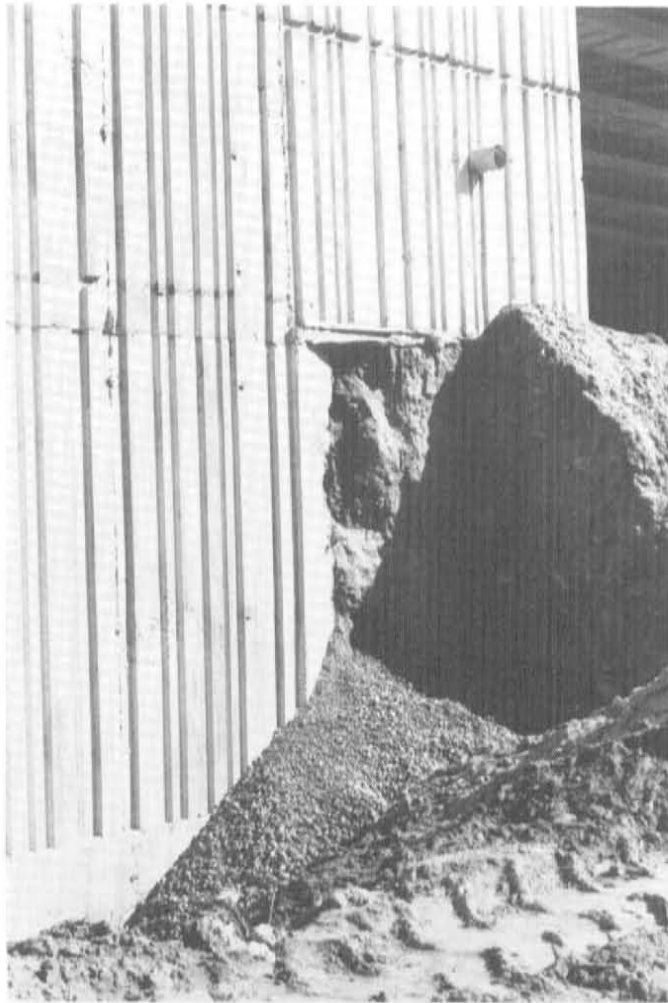
A problem developed at the interface of the bridge abutment wingwall and the Hilfiker concrete panels. Prior to the completion of the last panel of the wingwall, a significant amount of the backfill washed out due to heavy rainfall. Figure 29 shows the backfill material that had been lost through the abutment. Figure 30 is the crevice formed by the seepage. Figure 31 is the void created at the top of the embankment, noticeable because the PCCP had not yet been placed.

Figure 29 Backfill Material that Seeped Through Abutment Wingwall.

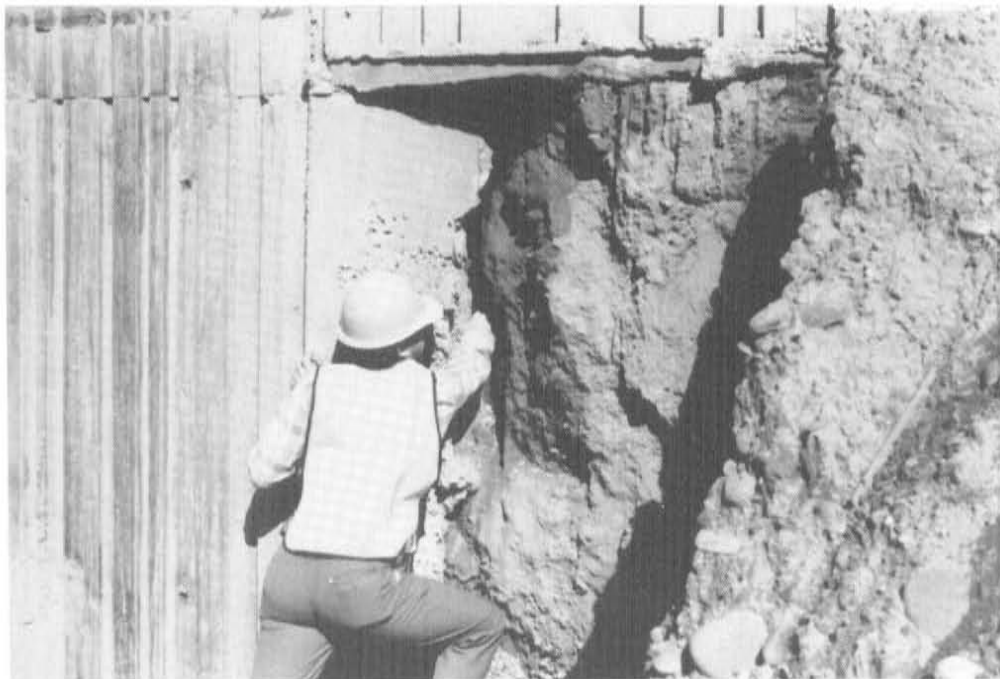
Figure 30 Crevice Formed by Washout of Backfill Material.

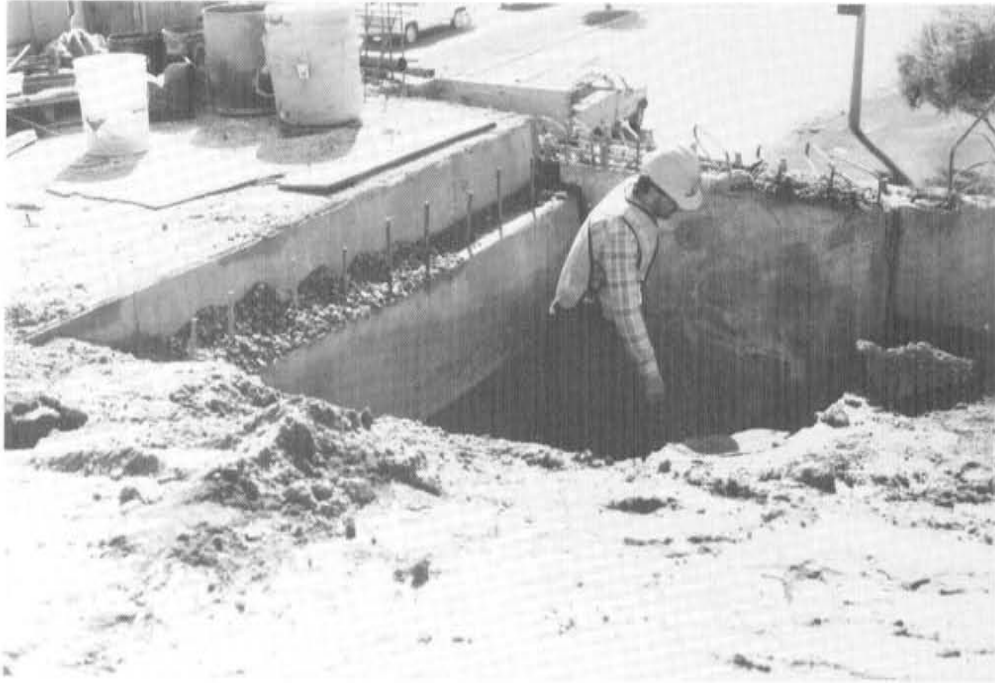
Figure 31 Void at the Top of the Embankment Due to Loss of Backfill Material.

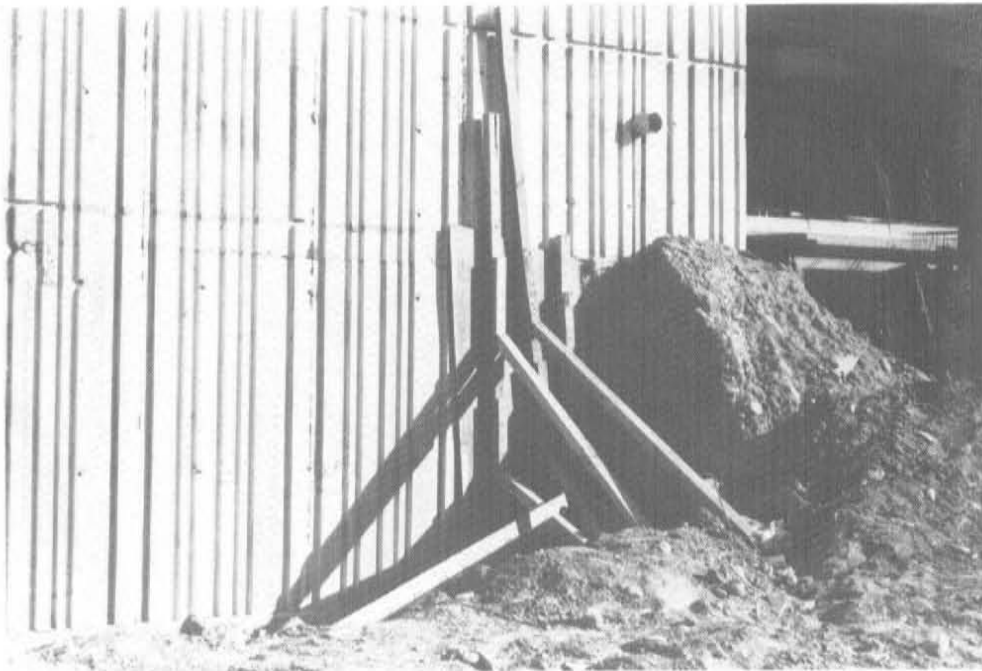
Figure 32 Support to Bridge Abutment for Refilling Rain Caused Crevice.

To remedy this situation, the contractor supported the bottom of the abutment wingwall as shown in Figure 32, and filled the void with a structural backfill material. The material was then compacted with a jetting technique.

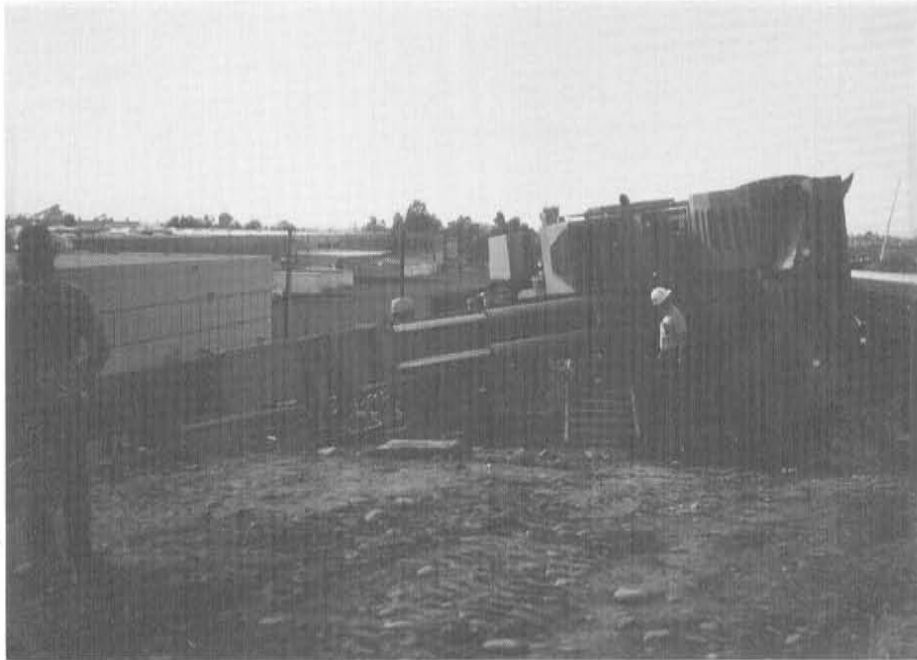
During the placement of the forms for the concrete panels, a crane overturned and damaged the wall's steel reinforcement. Figures 33 and 34 show the overturned crane and the resulting damage. Apparently the operator failed to extend the crane's outriggers prior to lifting some forms. The damage was repaired by straightening the steel and placing additional rebar. Figure 35 shows the site of the damaged section after repairs had been completed.

Figure 33 Overturned Crane on SW Embankment.

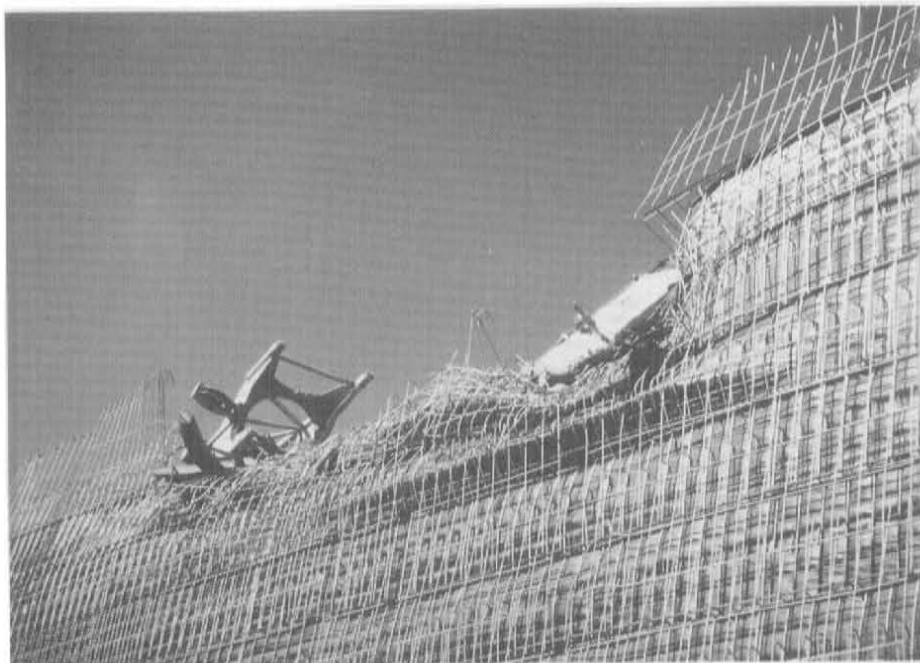
Figure 34 Damage Caused By Overturned Crane.

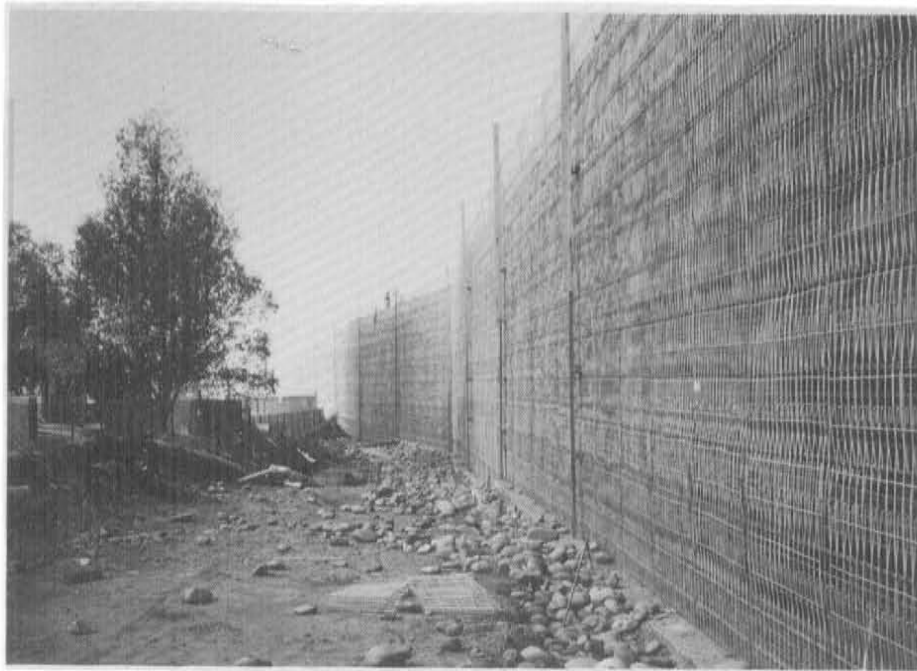
Figure 35 Site of Damaged SW Wall Section After Repair.

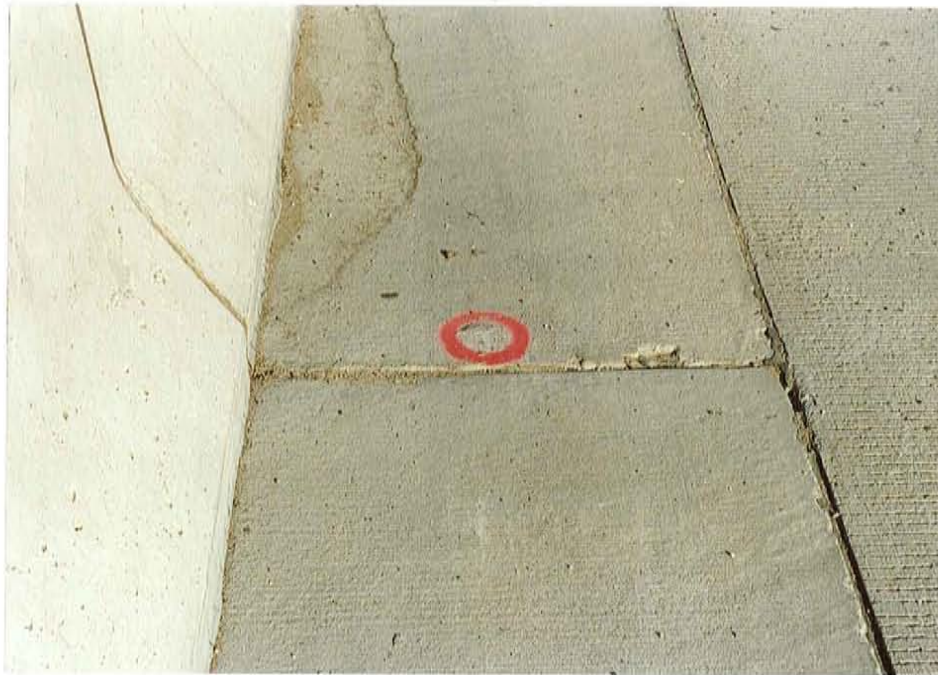
The aluminum caps embedded in epoxy on the southeast wall have been removed. Apparently they were scraped off by some sort of heavy vehicle, although this would be difficult considering the caps proximity to the concrete barriers placed on top of the wall. Figure 44 shows the location of a removed aluminum cap.

Figure 44 Aluminum Caps of the SE Wall Have Been Removed.

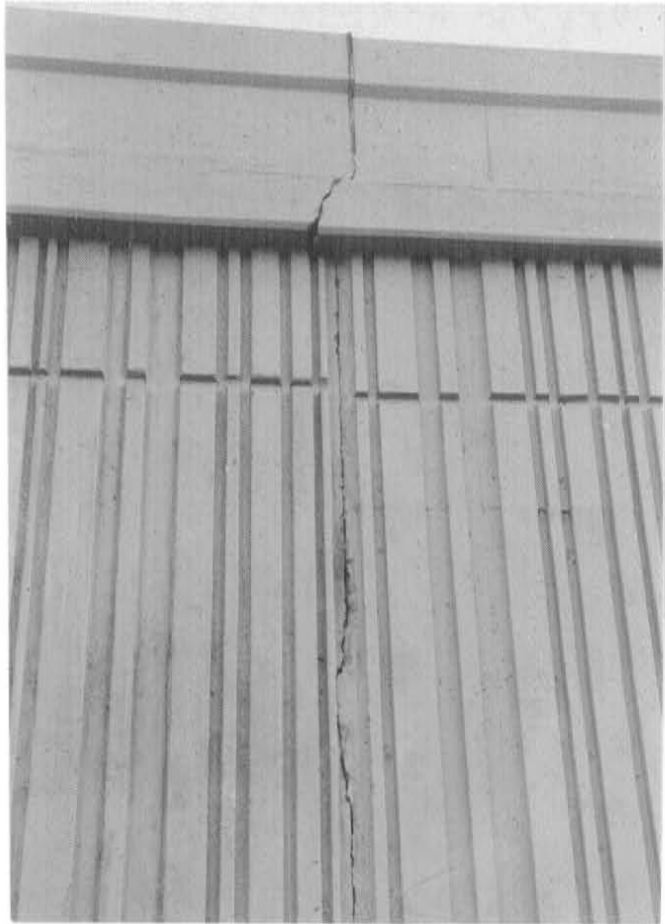
There is a large (0.5" to 1.5") vertical crack at the interface between the southeast Hilfiker wall and the southeast abutment of the I-10 and 24th Street bridge. The retaining wall has settled about an inch relative to the bridge abutment at this point. Figure 45 is a photo of this crack along the face of the wall, and Figure 46 shows the damage to the concrete at the top of the wall at the crack.

Figure 45 Vertical Crack at the Interface of the SE Wall and the Bridge Abutment.

A hypothesis as to the cause of the large vertical crack is differential settlement between the bridge abutment and the Hilfiker wall/embankment. The bridge abutment is on piers, whereas the Hilfiker system is not.

6. Continued visual monitoring and comparison surveys on the walls is recommended. Documentation of the methods used to correct existing distresses is also desirable.

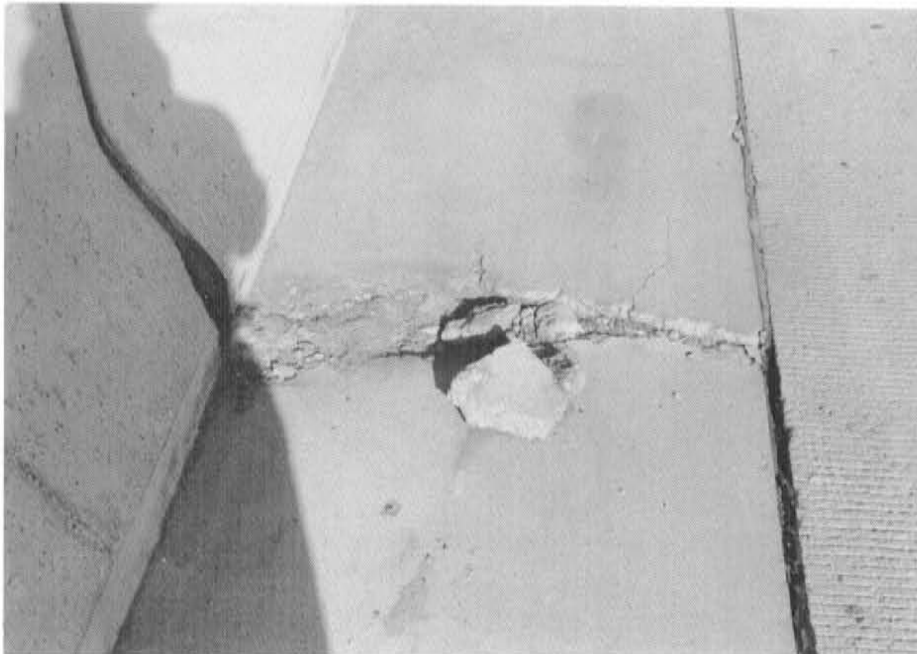
Figure 46 Damage to the Concrete at the Top of the Cracked Interface.

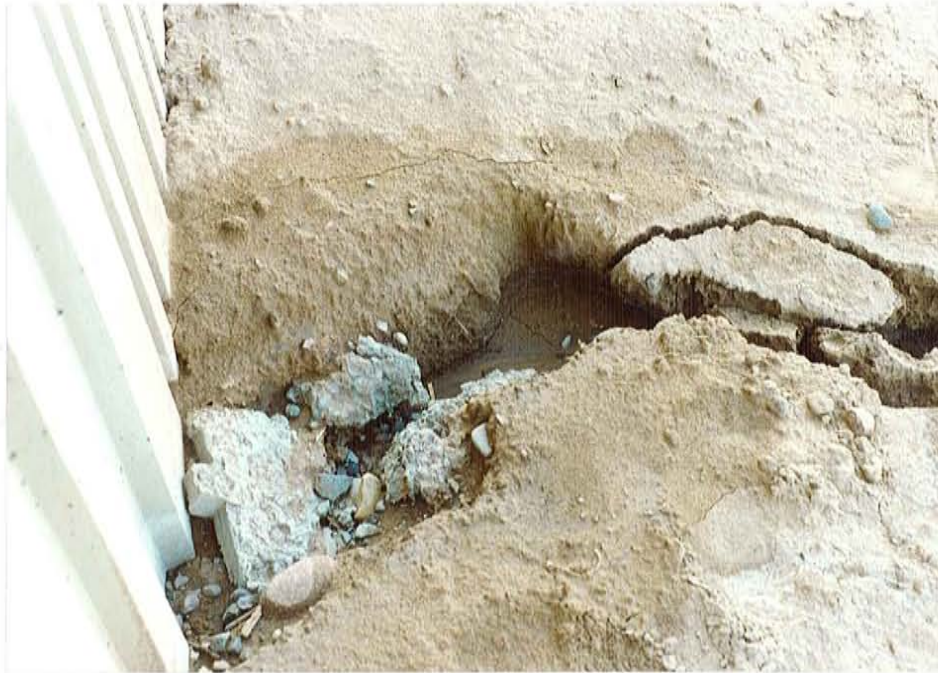
A large erosion channel had formed immediately below the vertical crack, yielding evidence that water was entering the reinforced earth embankment and exiting through this crack. Following rains it was noticed that sediment was carried into 24th Street. Figure 47 shows the erosion channel, which has at times been filled in by landscape maintenance crews.

Figure 47 Erosion Channel Immediately Below Vertical Crack of the SE Wall.

A probable cause of the observed deflection of anchor slab is the formation of a void in the embankment. The void could be caused by the washing out of embankment material through the large vertical crack at the wall - abutment interface. This would be consistent with the washout problems encountered with the southwest Hilfiker wall during construction as seen in Figures 30, 31, and 32.

5. Proper drainage should be provided for the retaining system. Drains should include sand or synthetic filters to prevent the loss of material from the embankment. This recommendation is in light of the extreme difficulty in keeping water from entering the embankment.

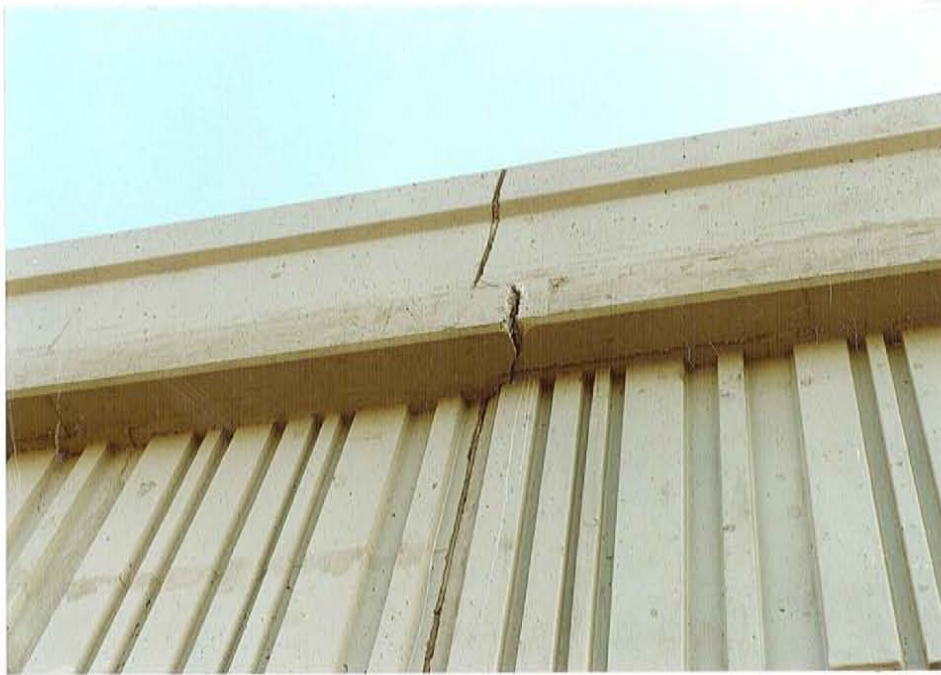
The two other Hilfiker walls were subject to similar phenomena; vertical cracks at the bridge abutment interface. However, the cracks were not as severe. Below the southwest wall crack there was a small erosion channel. There was not a channel below the northeast wall crack. Figures 48 and 49 show the Hilfiker wall - bridge abutment vertical cracks for the southwest and the northeast walls. Many hairline vertical and horizontal cracks are visible throughout all three of the retaining walls at this interchange.

Figure 48 Interface of SW Hilfiker Wall and the 24th Street Bridge Abutment.

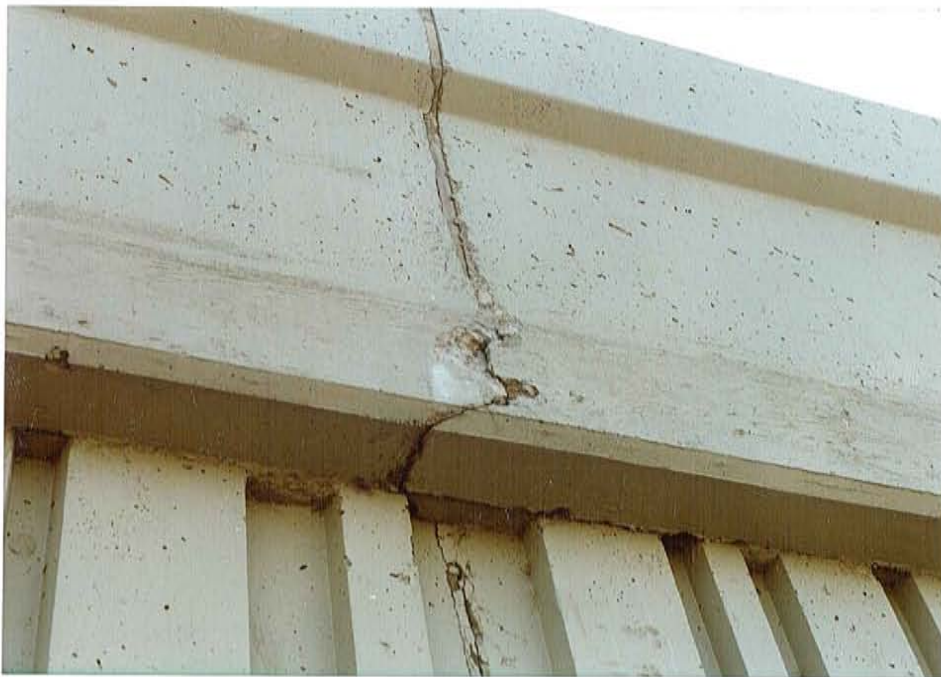
Figure 49 Interface of NE Hilfiker Wall and the 24th Street Bridge Abutment.

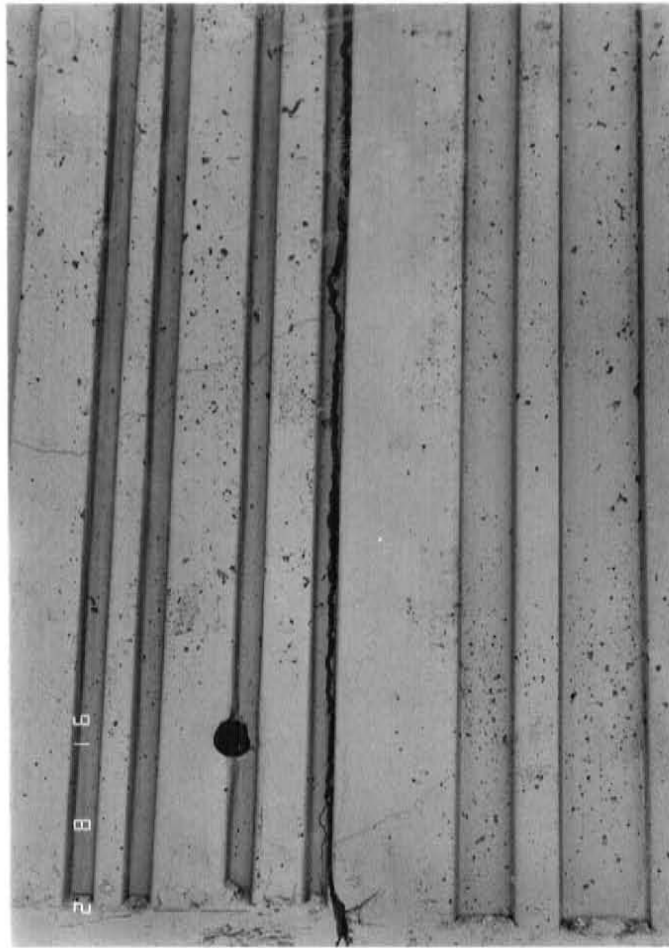
Inspection of this facility included mapping the vertical cracks, expansion joints, and weep holes of both sections of the wall, and recording the widths of the vertical cracks. The cracks varied in width from 0.007" to 0.1" with the exception of a single large vertical crack along the west face of the Hilfiker wall. The crack is 0.5" wide; however, there is no vertical displacement across the crack at the top of the wall. Figure 52 is a photo of this large vertical crack. APPENDIX I is a record of the location and size of cracks, expansion joints, and weep holes along both the gravity wall and the Hilfiker Wall.

Figure 52 Large Vertical Crack Along the West Face of the Hilfiker Wall at the Moreland Street Drop Structure.

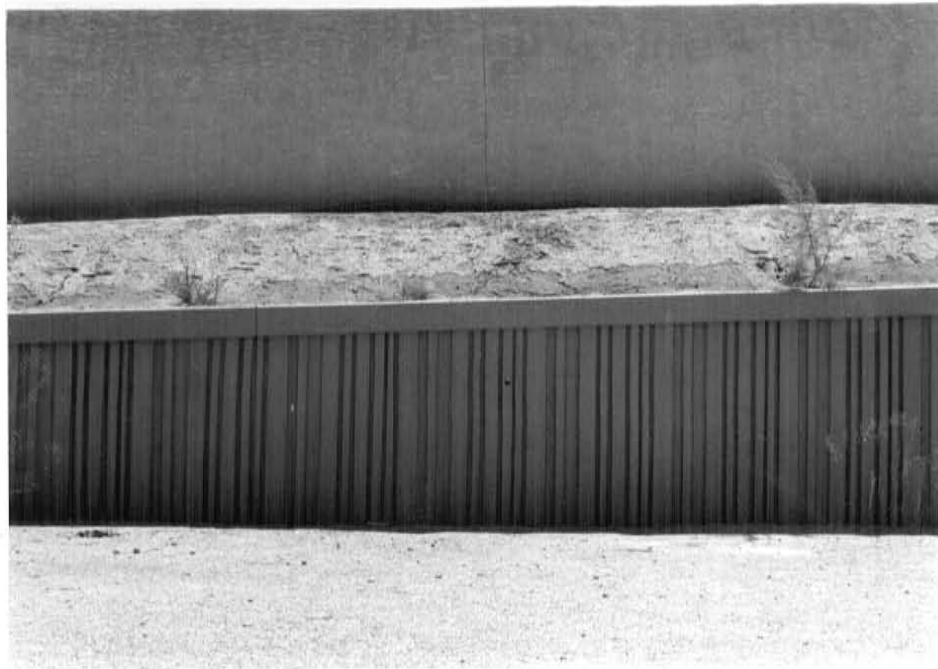
Inspection of this site consisted of walking the length of the retaining wall and recording the location of vertical and horizontal cracks, and expansion joints. The cracks were approximately 0.02" wide. The record is included as APPENDIX J. Figure 55 is a photograph of the retaining wall at the Warner Road Interchange.

There were plant wells placed at 8' intervals along the top of the retaining wall. Plants were no longer growing in these wells, but the drip irrigation system was continuing to operate. Also, irrigation of the plants immediately east of the sound wall was noticeably seeping down slope through the soil beneath the sound wall. The moisture was evident all the way down to the retaining wall. Because of the absence of weep holes in the retaining wall, the situation of additional water in the soil could be reducing the stability of the retaining wall. The drip irrigation system of the vacant plant wells has since been shut down. There were no major distresses visible on the wall.

Figure 55 Hilfiker Wall at the Warner Road Interchange.
